EVG HELPED SCA ORTVIKEN PM1 TO IMPROVE WIRE SECTION PERFORMANCE

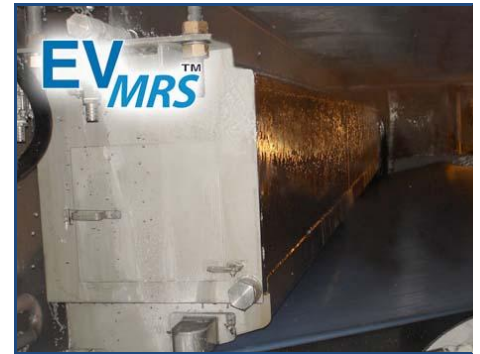
At the bottom wire, high pressure wire cleaning shower was spreading very misty air with fibers and fillers in the area, because the old type of mist suction box of the area operated with very poor performance.

This caused contamination on machine constructions and frames, and defects because of dropping water and filler clumps.

EV MRS at bottom wire

To solve these problems, EV Group offered the mill technology for top wire ventilation and modern bottom wire mist removal (EV MRS™) for high speed paper machines. Installation took place in May, 2008. The mill experience shows the wire section performance has clearly improved after the project.

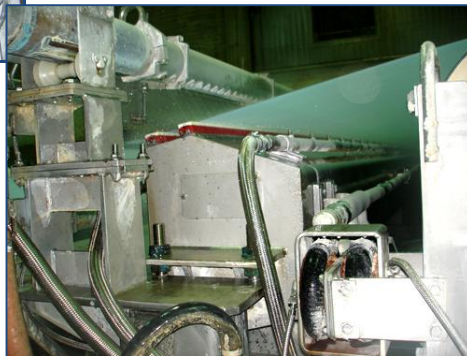
SCA Ortviken PM1
fourdrinier with top wire
grade LWC
width 7,1 m
speed 1350 m/min
